WHISKER/CONE GROWTH ON THE
THERMAL CONTROL SURFACES EXPERIMENT #S0069

James M. Zwiener
James E. Coston Jr.
NASA Marshall Space Flight Center
Huntsville, AL 35812
Phone: 205/544-2528, Fax: 205/544-5103

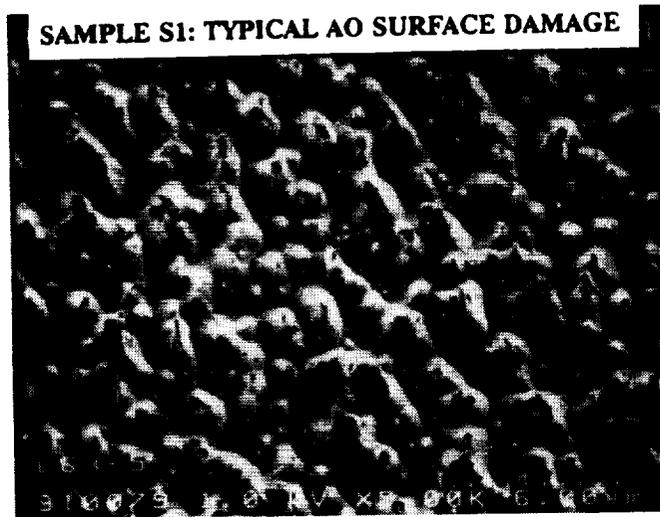
Figure 3. SEM Images of Teflon Surfaces on S0069 for covered and exposed locations.

AO erosion of the exposed Ag/FEP surface, sample S1 in Figure 3, is typical of that observed on other LDEF experiments^{17,18}. Erosion of the exposed Teflon surface creates a nonuniform etching pattern. This results in a roughened surface which scatters incident light in a manner similar to a sandblasted piece of glass, providing an overall diffuse whitish color. SEM photographs of the Teflon surface on either side of the whisker/cone growth region are also shown in Figure 3. The covered region of sample T51 appears to show contamination deposits or layers. Apparent AO erosion on sample T51 in the exposed region near the growth shows a radical variation in the normal Teflon erosion surface morphology. All three images are at approximately the same magnification, yet erosion near the growth area is composed of roughly parallel ridges. These ridges are parallel to the local overlapping covers. Close inspection of the sample T51 image for the exposed region near the growth reveals what appears to be growth on the top of the central ridges, as would be expected if the ridges provide the nucleation site for growth initiation. Crystal or dendritic growth always initiates (all other parameters being equal) at surface defect sites or on sharp pointed protrusions.

SAMPLE T51: COVERED REGION NEAR GROWTH

SAMPLE S1: TYPICAL AO SURFACE DAMAGE

SAMPLE T51: EXPOSED REGION NEAR GROWTH

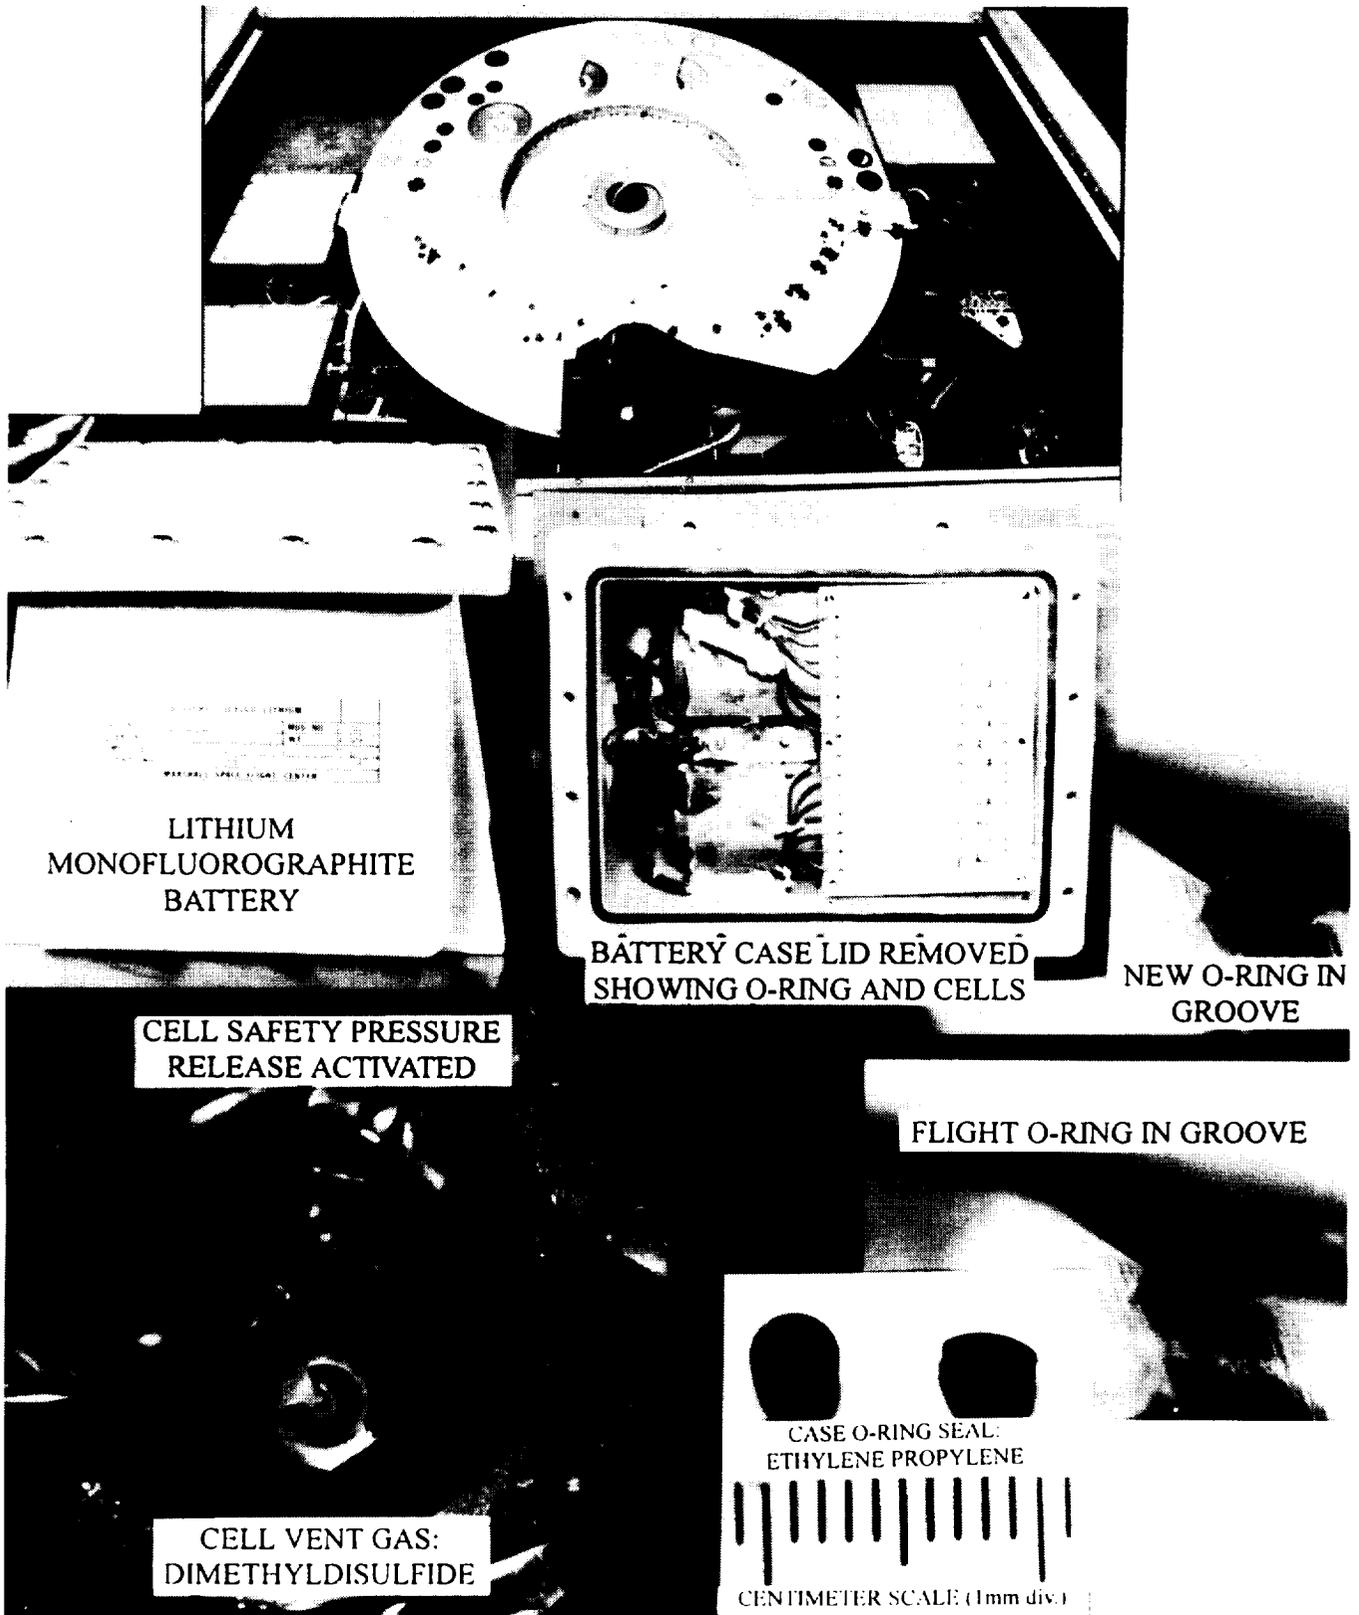
Figure 11. S0069 Lithium Monofluorographite Batteries and Leakage of Dimethydisulfide Gas.

Figure 11 is a mosaic of photographs showing the returned flight batteries in the S0069 experiment tray (four batteries were used; one is hidden under the carousel). One of the batteries is shown with and without its lid in place. Individual cells are potted in the battery case, as can be seen in Figure 11. For these batteries it was found through investigations at MSFC* that after approximately three years (even in cold storage) the individual nickel cell safety pressure release would rupture. Figure 11 shows an individual cell with the pressure release ruptured. Dimethyldisulfide gas is vented by these cells when they rupture. In conjunction with the cell rupture, the battery case seal leaked when the o-rings (ethylene propylene) failed from compression set. Figure 11 clearly shows the magnitude of the compression set. A cross section of the flight o-ring compared to an unused o-ring shows that the flight o-ring has taken the shape of its groove indicating 100% compression set. The dimethyldisulfide gas vented from the batteries is the most likely source of the sulfur detected in the growth.

During post flight investigation, when the S0069 cover was removed, very odiferous fumes were detected. Gas samples were taken using organic (activate charcoal) vapor monitors located inside the S0069 TCSE instrument with the shipping cover in place. Three monitors were located inside the instrument and one control was placed outside. Analysis identified the gas as dimethyldisulfide. Batteries were then removed and double bagged. Gas samples were taken from the bag using a vacuum bottle technique and analyzed at MSFC. As before, the gas was identified as dimethyldisulfide.
